Environmental Due Diligence

Canteen
Settimo Milanese/Cornaredo (MI)

Revision:	00
Date:	02/12/2020
Project n.:	2206187
Prepared for:

Data Center Investment SARL

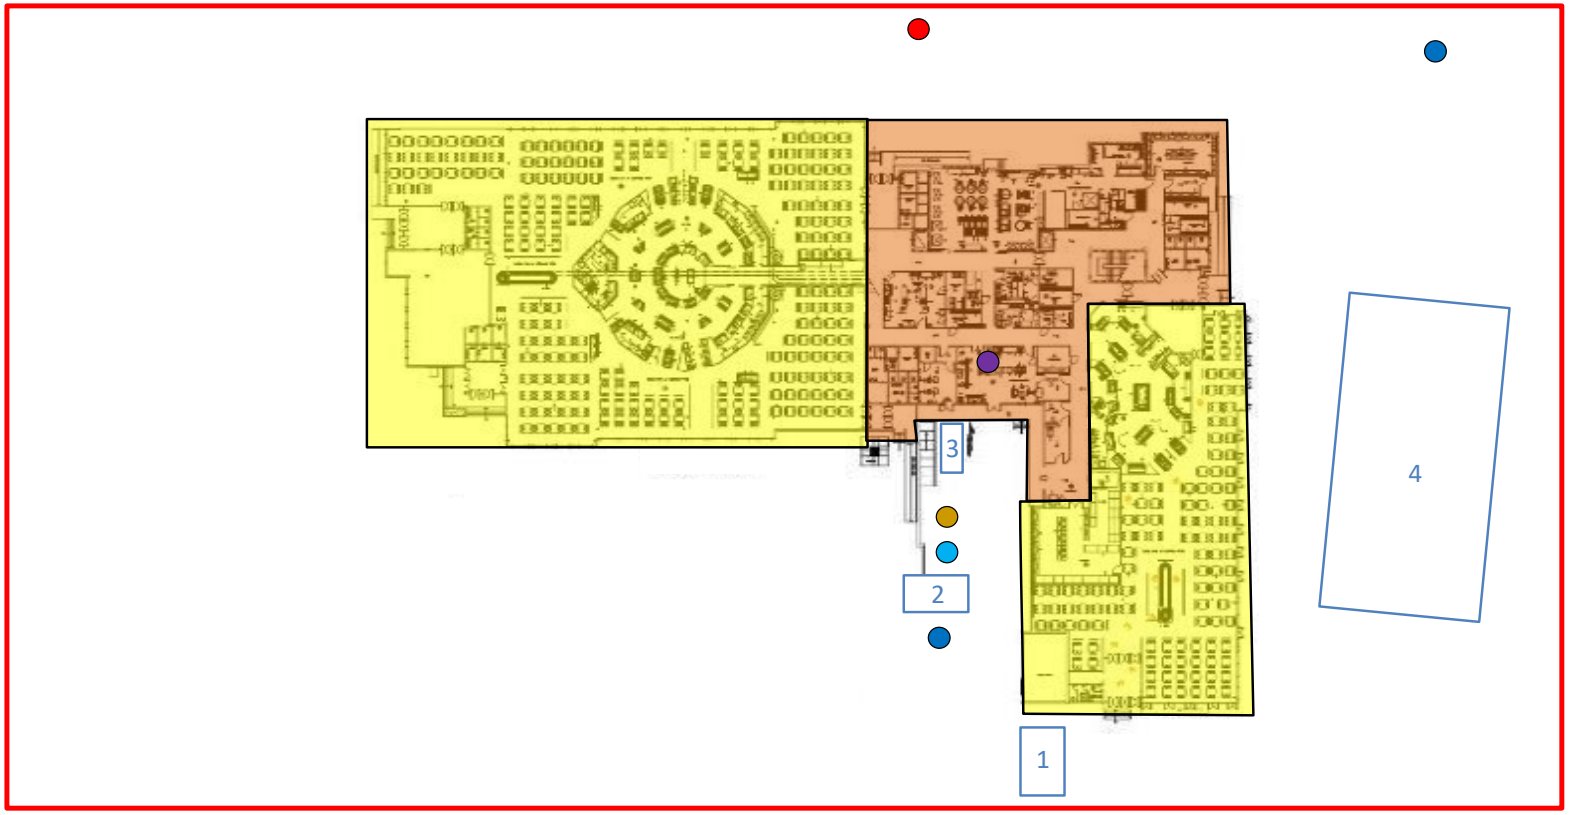
SITE LAYOUT

Site Perimeter	2	Electrical substation		Potentially hazardous waste (roofing)
	Canteen area	3	Metal container for waste storage		Unused cooling system
	Kitchen area	4	Artificial water pond		Active cooling system
1	Heating plant		Abandoned fiber cement slabs, potentially containing Asbestos		Water wells

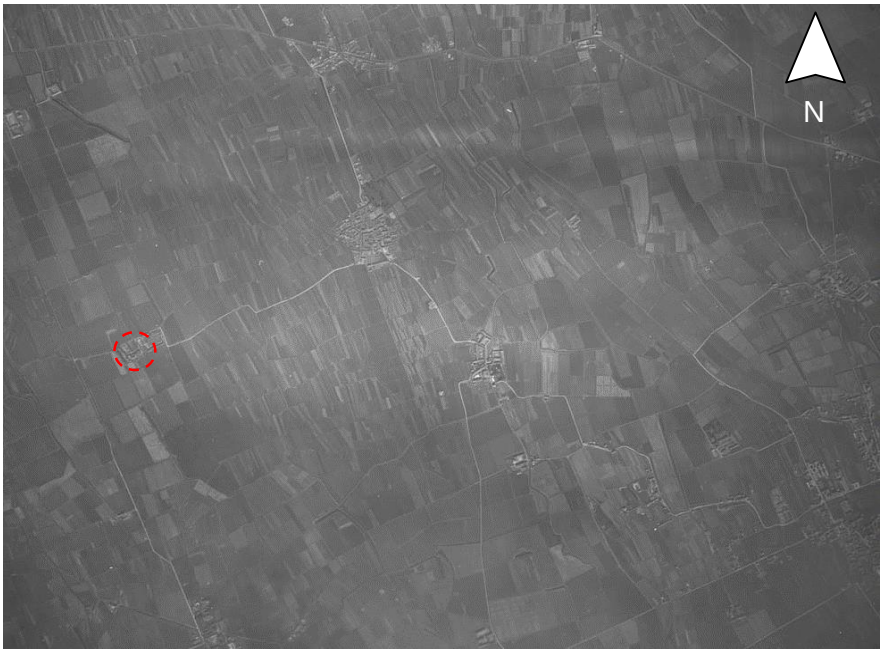
#	Date	Source
1	1951	Geographic Military Institute

The Site appears to be characterized by the presence of buildings.
No further information is available due to the low resolution of the photo.

Surrounding areas appears to be agricultural lands.
No further information is available due to the low resolution of the photo.

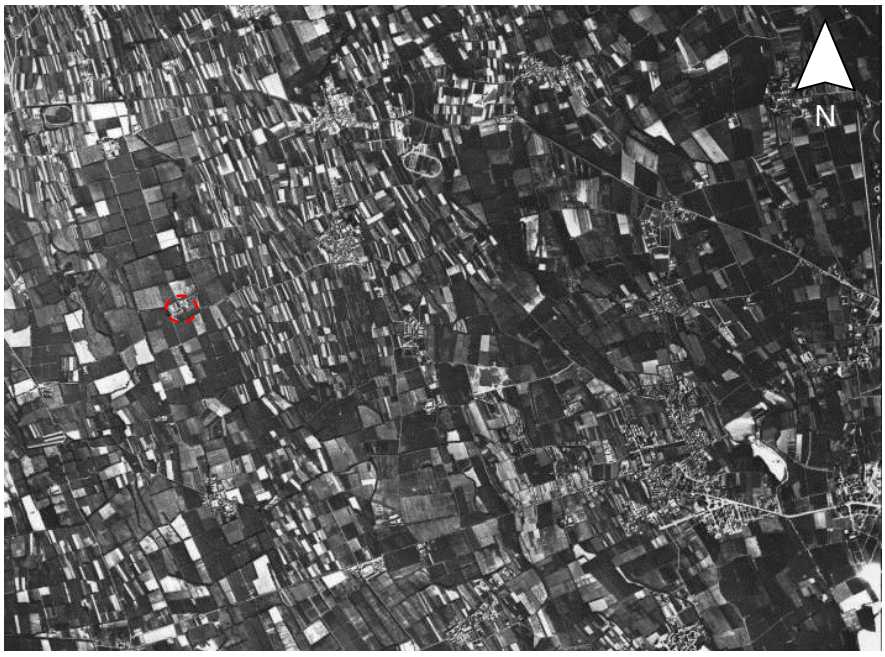
#	Date	Source
2	1955	Geographic Military Institute

No significant changes in the Site layout.
No further information is available due to the low resolution of the photo.

No significant changes in the surrounding areas.
No further information is available due to the low resolution of the photo.

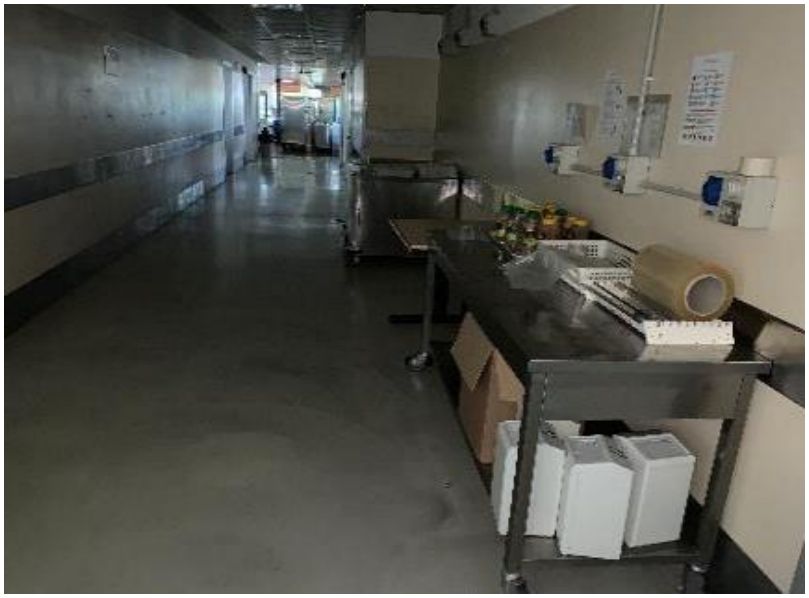
#	Date	Location
18	28.10.2020	Canteen - Inside area

View of the central part of the building.
